POR 6337 · (WT-6337)

SHOT MING VASE

MING VASE INTERIM SUMMARY REPORT

November 1969

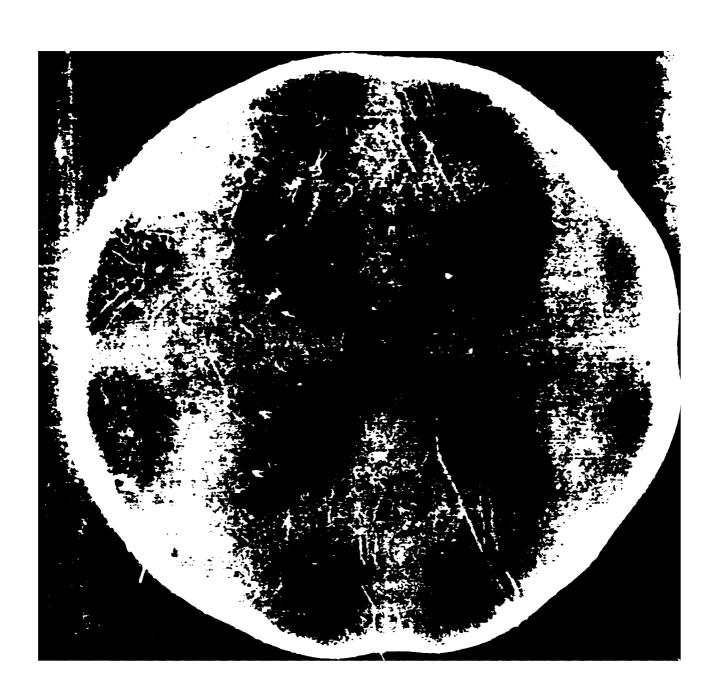
1. The wire mesh around the pipe where it ruptured just

forward of TAPS 1 caught considerable large debris (timber,

rock, etc.) preventing it from entering the pipe (Figure

Piqure 3.2 7 (DASA 353-10-MCS-68)
